Chicago Music and Dance Theater

Phase I Environmental Assessment

319 E. Illinois Street
Chicago, Illinois

RE: Phase I Environmental Assessment of the Proposed Chicago Music and Dance
Theater Site at 319 E. Illinois Street, Chicago, Illinois – STS Project No. 24418-XB

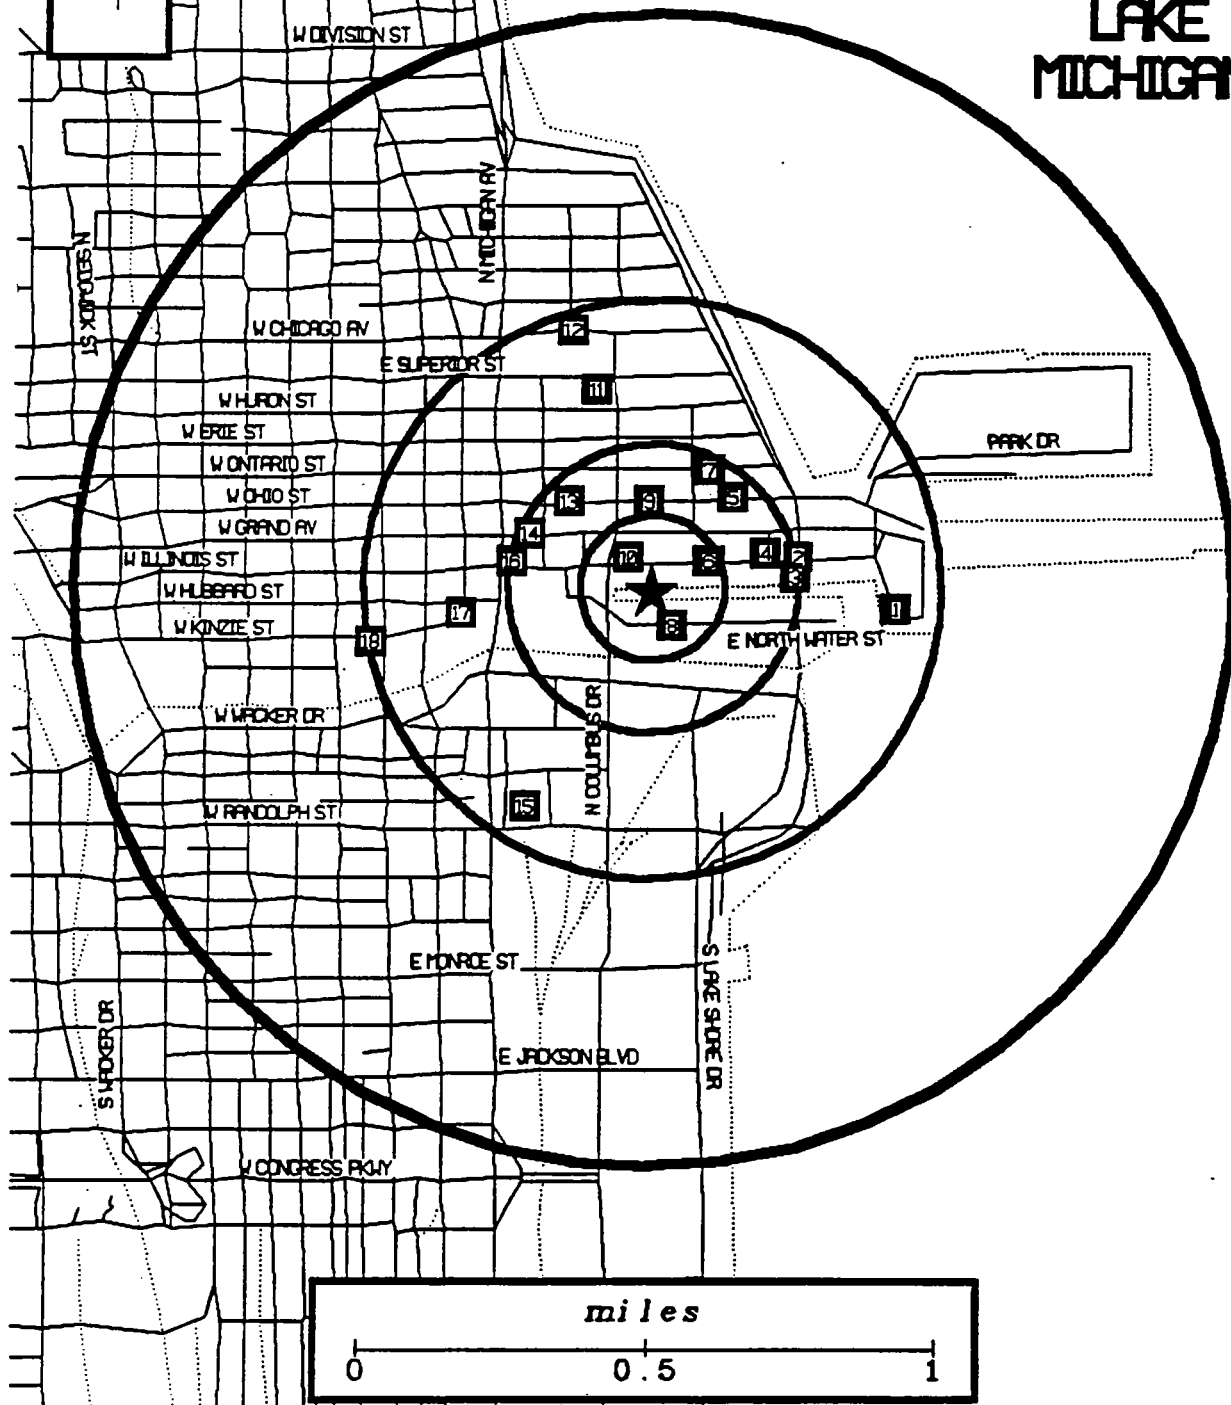
**HAZARDOUS WASTE FACILITIES
CITYFRONT CENTER
CHICAGO MUSIC & DANCE THEATER
CHICAGO, ILLINOIS**

The next closest site is Lindsay Light Company at 161 E. Grand Avenue, 0.24 miles northwest of the subject site (#14 on Figure 4). This site also was suspected to have elevated levels of gamma radiation, but according to Mr. Rollins, the levels found were not significantly above background levels and no further action is planned at the site.

The next CERCLIS site is identified as Great Lakes Limited Partnership at 505 N. Lake Shore Drive, Suite 606, 0.26 miles northeast of the subject site (#2 on Figure 4). Al Altur of USEPA Remedial Response Branch stated that no further remedial action is planned for this site as of September 18, 1987. The final CERCLIS site found within a one-half mile radius of the subject site is listed as Heath & Mulligan at 170 Randolph Street, 0.43 miles southwest of the subject site (#15 on Figure 4). Mr. Altur said that no further action is planned for this site as of 1987. No additional information is available concerning these sites, but STS can submit a Freedom of Information Act (FOIA) request to the appropriate state and/or federal agency at the discretion of the Client.

3. Two (2) RCRA Large Quantity Generators were found within a one quarter-mile radius of the subject property. The closest site is Lakeshore Ontario Associates at 401 E. Ontario Street, 0.22 miles northeast of the subject site (#7 on Figure 4). Zetta Thomas of USEPA RCRA Enforcement Branch stated that no files exist for the subject site, and Brian White of IEPA RCRA Enforcement Branch stated that documentation dated 1989 exists for the site, and that a FOIA request would need to be submitted to obtain access to the State files.

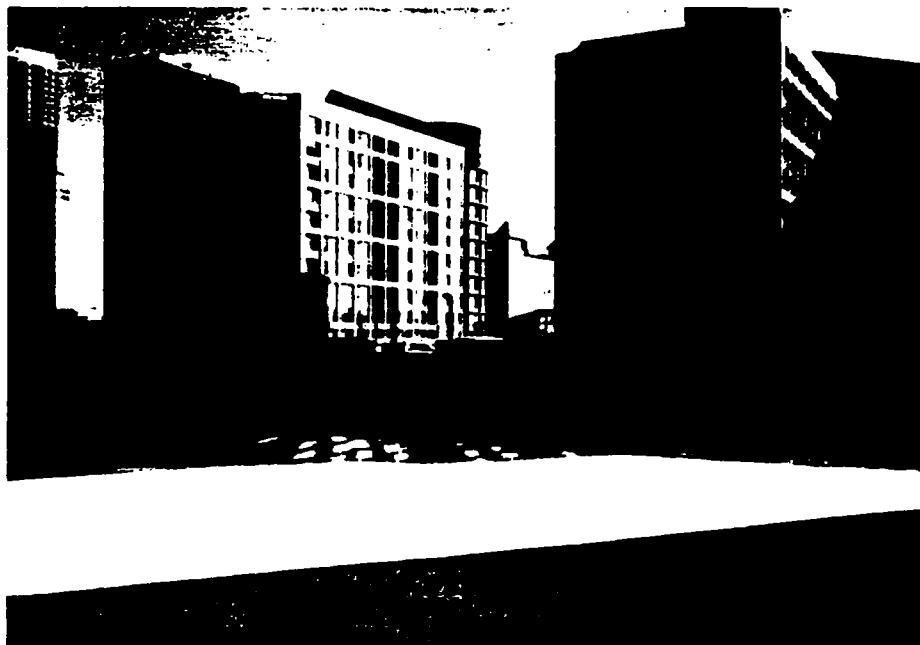
Photograph 2. Looking east across site to apartment building and garage on east side of New St.

- North - Northern portion of the grassy area, E. Illinois Street, and on the north side of E. Illinois is a municipal parking lot (photo #1).
- East - New Street, a mid-rise apartment building and associated parking garage (photo #2).
- South - Southern portion of the grassy area, E. North Water Street, Sheraton Chicago Hotel and Convention Center (photos #3 & 4).
- West - Park Drive, Ogden Plaza (a small city-style park), farther west is Columbus Drive and the NBC Tower (photo #5).
